GROUP	MODEL
	Safety Recall Campaign	2022-2024MY EV6, EV6 GT (CV)
	NUMBER	DATE
	SC302	May 2024

SAFETY RECALL CAMPAIGN

SUBJECT: ICCU AND FUSE INSPECTION/REPLACEMENT AND ICCU SOFTWARE UPGRADE (SC302)

This bulletin provides information to inspect and, if necessary, replace the Integrated Charging Control Unit (ICCU) and ICCU fuse on certain 2022-2024MY EV6, EV6 GT (CV) vehicles produced from November 17, 2021 through February 7, 2024. This bulletin also provides information to update the ICCU software. The ICCU may become damaged over time from transient high voltage and thermal cycling resulting in a DTC P1A9096 stored. A damaged ICCU may not be able to charge the 12-volt battery which can discharge gradually while driving with progressive reductions of motive power. If the driver ignores the warnings associated with the discharging battery condition and continues to operate the vehicle in a reduced power mode, the vehicle may eventually experience a complete loss of motive power, increasing the risk of a crash. Follow the procedure outlined in this publication to 1) inspect and, if necessary, replace the ICCU and ICCU fuse, and 2) update the ICCU software on the affected vehicle.

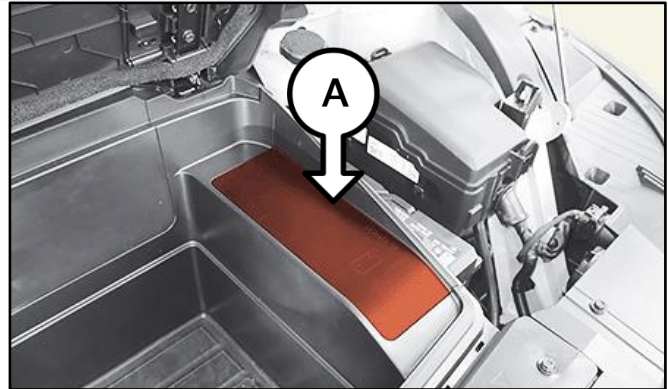
1. Open the hood and open the auxiliary battery (12V) service cover and fuse (A).

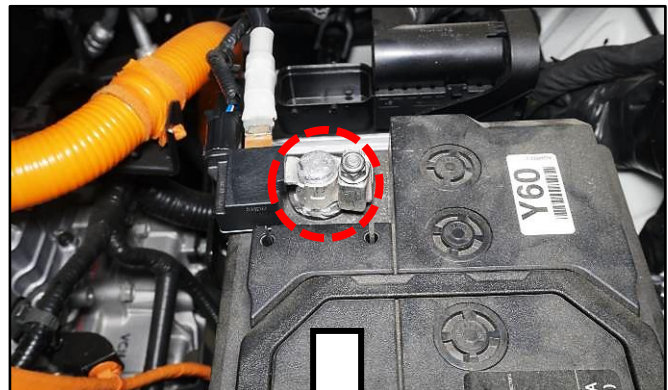
2. Open the hood and disconnect the battery negative (-) post cable.

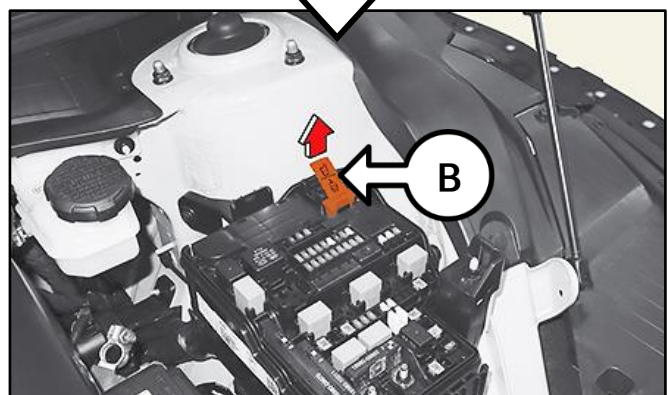
3. Remove the room junction block cover and disconnect the service interlock connector (B).

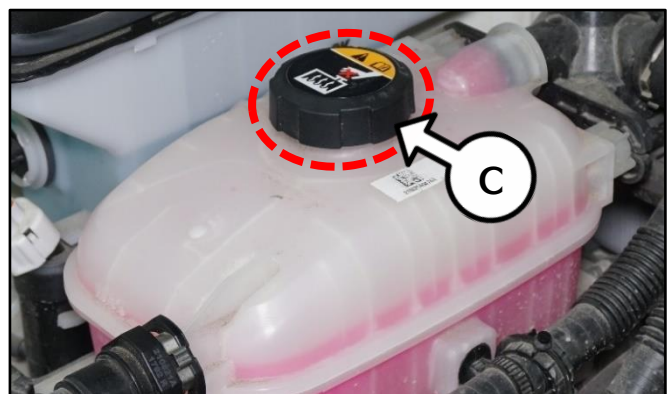
4. Open the coolant reservoir tank pressure cap (C) to release pressure.

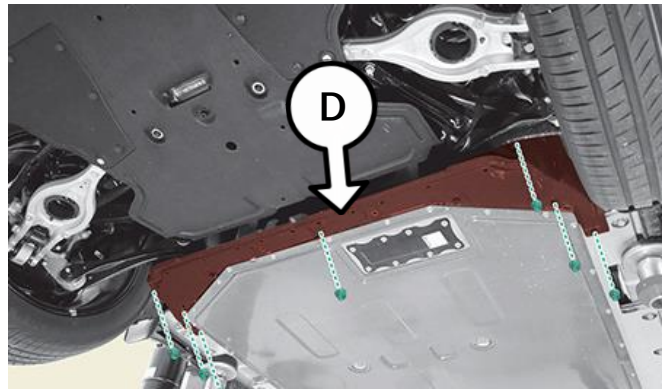
- Remove the rear under cover (D).

Tightening torque for nuts:
5.8 - 8.7 lb.ft (7.8 - 11.8 N.m)

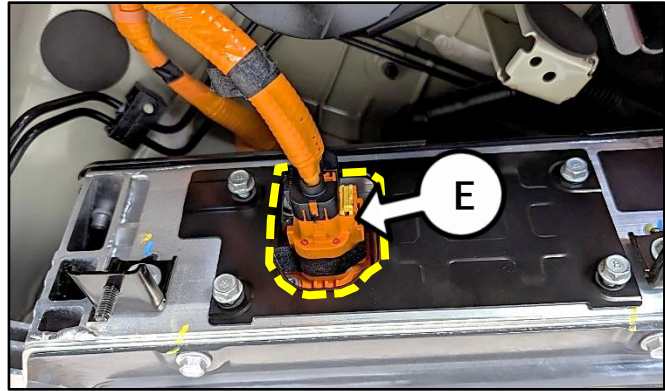
- Disconnect the ICCU Connector (E).

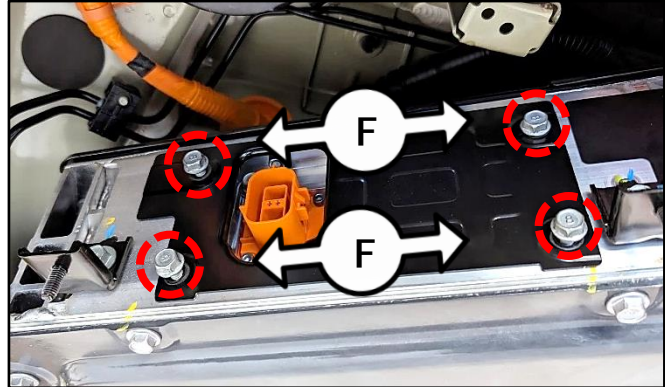
- Remove the four (4) ICCU fuse service cover retaining bolts (F).

Tightening torque for bolts (F):
5.8 - 8.7 lb.ft (7.8 - 11.8 N.m)

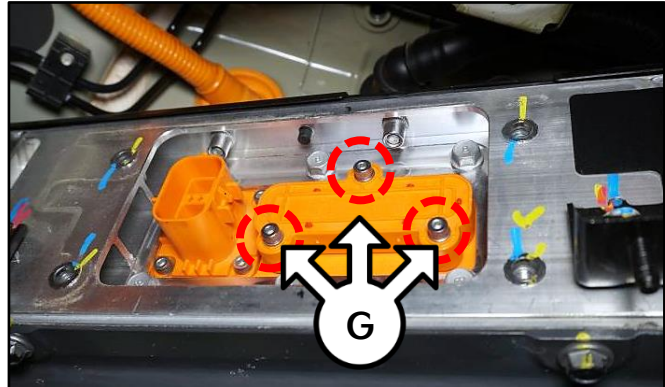
- Remove the three (3) ICCU fuse cover retaining bolts (G).

Tightening torque for T3 hex bolts (G):
22.6 - 29.5 lb.in (2.5 - 3.3 N.m)

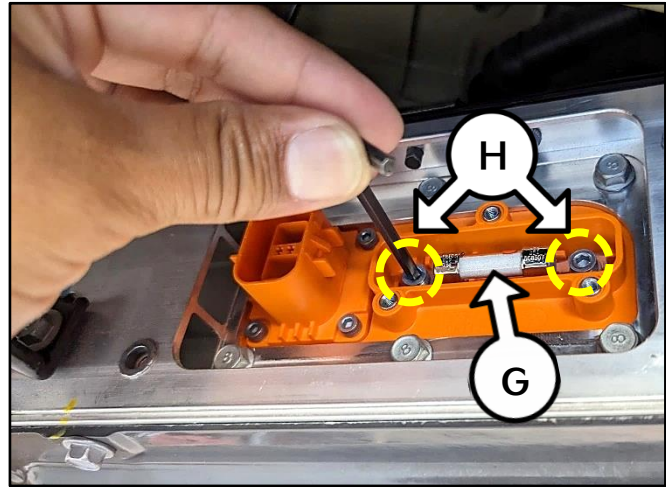
9. Carefully and gently remove the two (2) ICCU fuse (H) retaining allen head bolts (H) using a hand tool and replace the ICCU fuse (I) with a new part.

DO NOT use a power tool to remove these bolts. There are two (2) securing nuts inside the battery. If the nuts fall inside the battery, additional time will be required to extract them.

Tightening torque for T5 hex bolts (H):
39.1 -47.7 lb.in (3.3 - 4.0 N.m)

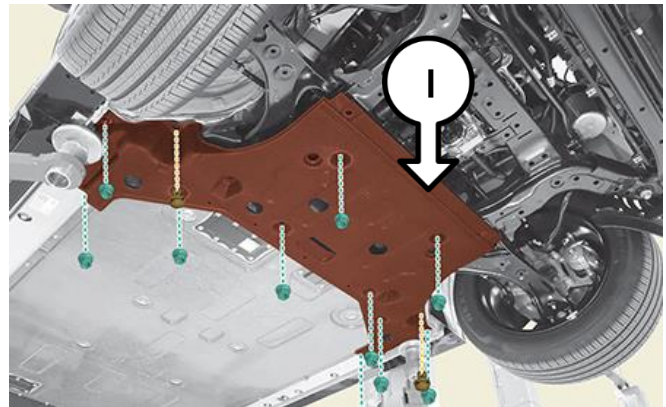
11. Remove the front rear under cover (I).

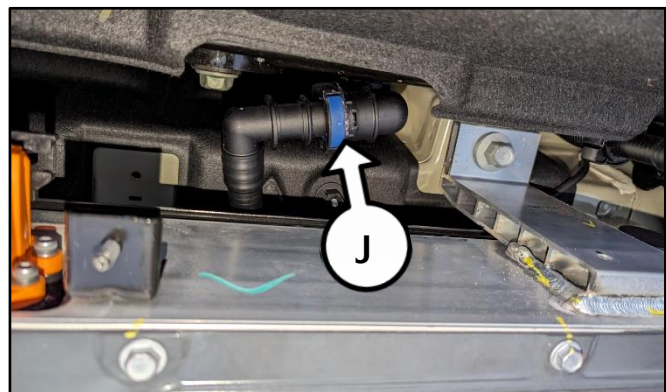
Front of Battery

12. Disconnect the blue rear coolant hose connector (J).

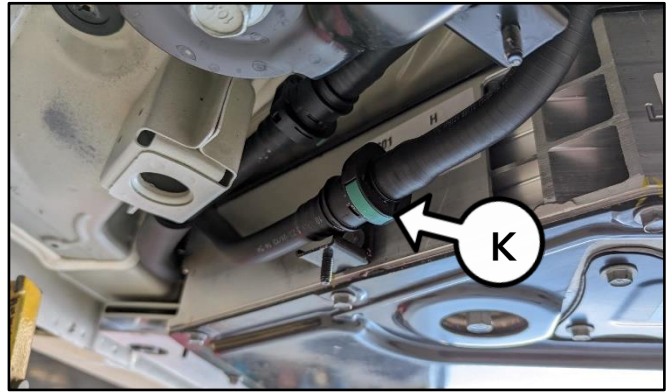
Rear of Battery

- 13. Disconnect the front coolant **green** hose connector (K).

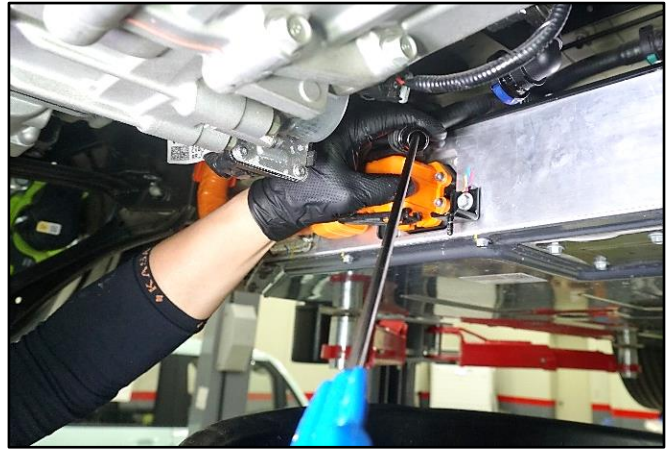
Front Right Side of Battery

- 14. Using shop air, blow out the ICCU coolant from the **blue** rear disconnected coolant hose.

Wearing a rubber glove, create a tight seal using hand when blowing into the **blue** hose connector end.

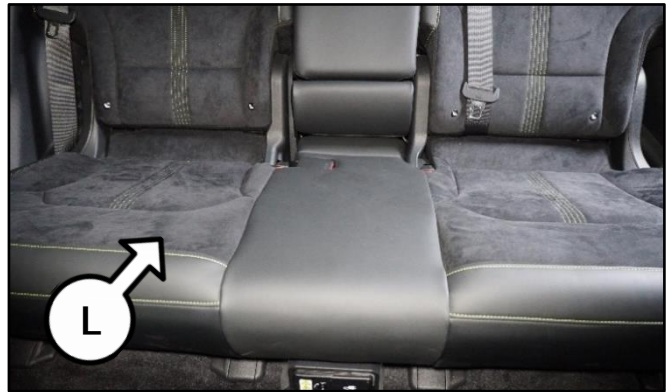
- 15. Remove the rear seat assembly (L) by referring to "Body Interior and Exterior → Rear Seat Assembly → Removal and Installation" in the applicable Shop Manual on KGIS.

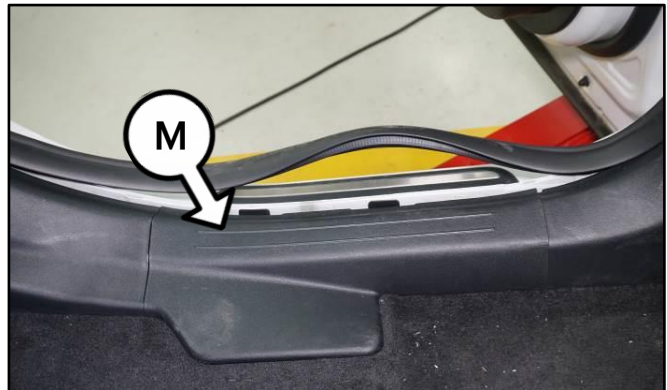
- 16. Remove the left (LH) and right (RH) side rear door scuff trim (M).

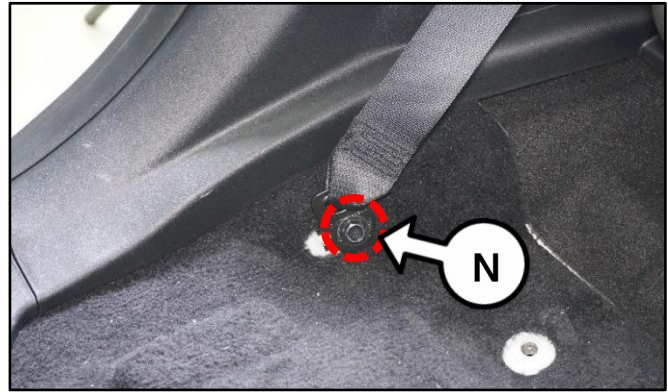
17. Remove both (LH and RH) the rear seat belt lower anchor retaining bolts (N).

Tightening torque for bolt (N):
29.7 - 44.1 lb.ft (40.2 - 59.8 N.m)

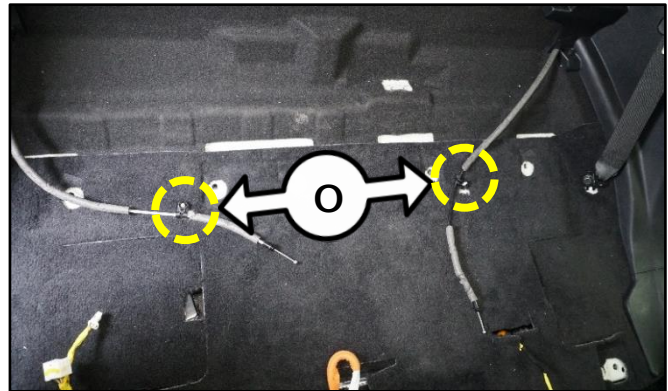
18. Detach the two (2) folding lever cables (O) from the floor carpet.

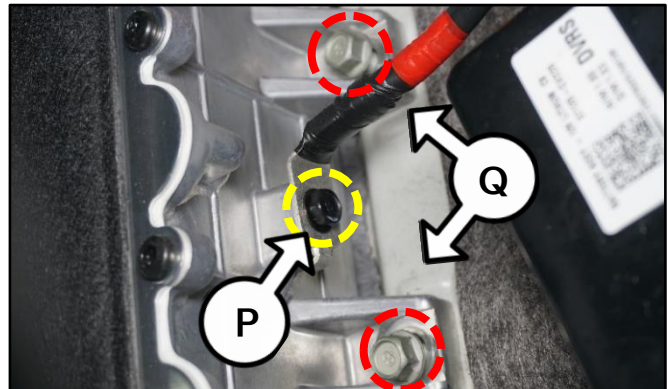
19. Disconnect the LDC cable by loosening the retaining bolt (P).

20. Remove the two (2) ICCU retaining bolts (Q).

Tightening torque for bolt (P):
5.8 - 8.7 lb.ft (7.8 - 11.8 N.m)

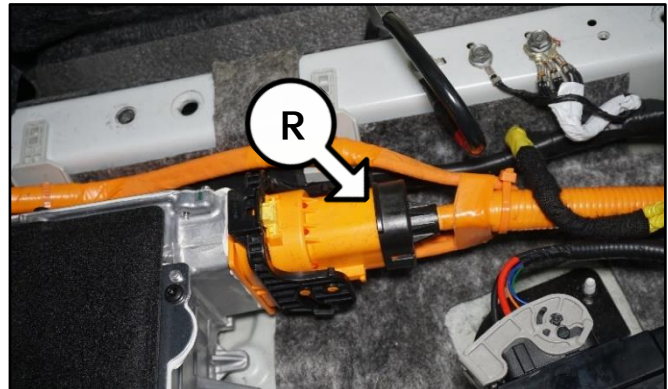
21. Disconnect the combo charge inlet wire harness connector (R).

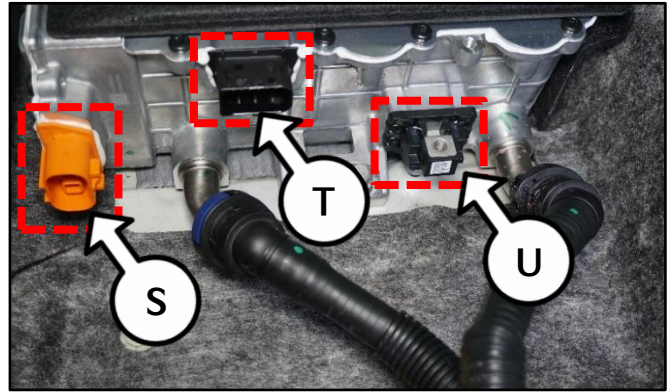
22. Disconnect the following:

- HV power connector (S)
- ICCU connector (T)
- LDC positive (+) cable (U)

Tightening torque for bolt (U):
5.8 - 7.2 lb.ft (7.8 - 9.8 N.m)

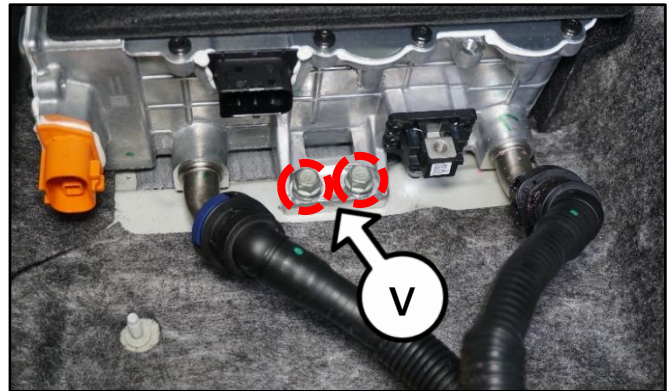
23. Remove the two (2) ICCU assembly retaining bolts (V).

Tightening torque for bolts (V):
5.8 - 8.7 lb.ft (7.8 - 11.8 N.m)

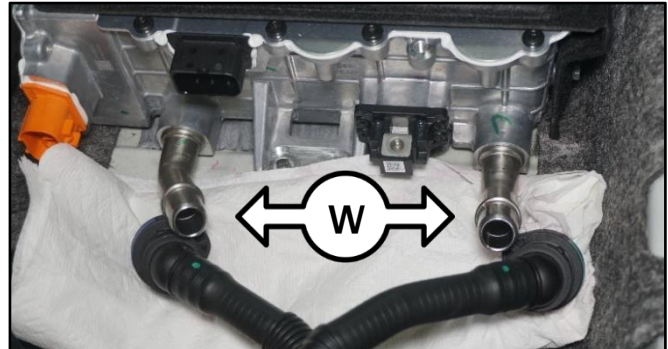
24. Disconnect the two (2) ICCU coolant hoses (W) from the ICCU assembly.

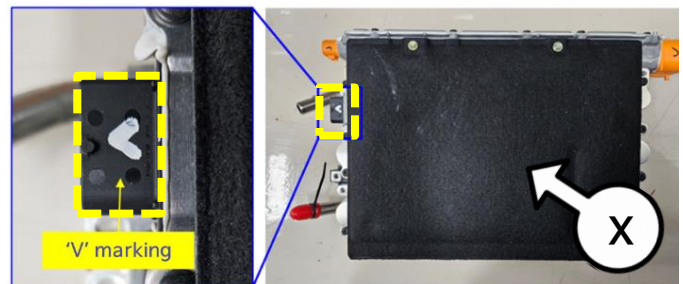
25. Replace the ICCU assembly (X) with a new part.

- **If the new ICCU part IS NOT marked with a "V", take a KVID photo and submit with claim. The software will need to be installed after replacement.**
- **If the ICCU is marked with a "V", the software was pre-installed.**
