GROUP	MODEL
Voluntary Service Campaign	2022-2024MY EV6 (CV)
NUMBER	DATE
SC311	June 2024

VCMS SOFTWARE LOGIC IMPROVEMENT (SC311)

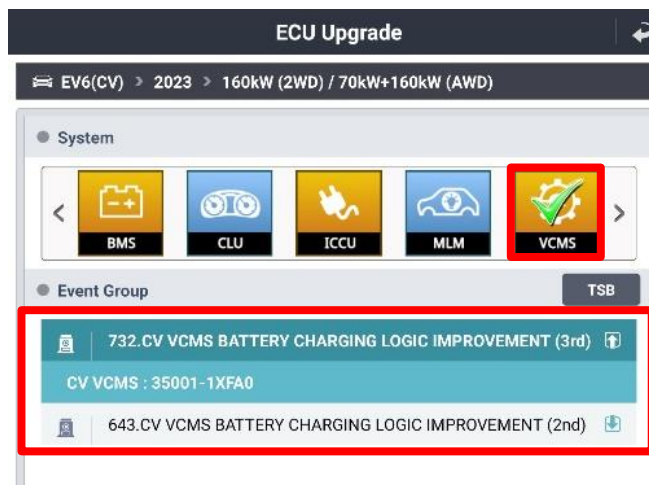
#732.CV VCMS BATTERY CHARGING LOGIC IMPROVEMENT (3rd) or
#674.CV eGT VCMS BATTERY CHARGING LOGIC IMPROVEMENT (P1BAD) - 2nd

Refer to [TSB SST081](#) for instructions to upgrade the 'VCMS' system:

Once the software has been installed:

1. Start the vehicle and confirm the WPC is operating properly by placing a Qi compatible phone on the charging pad and confirm the charging indicator light illuminates.
