GROUP	MODEL
BOD	2022MY EV6 (CV) GT-Line w/Electric Door Handles
NUMBER	DATE
307	May 2022

TECHNICAL SERVICE BULLETIN

SUBJECT: **ELECTRIC DOOR HANDLE NOISE**

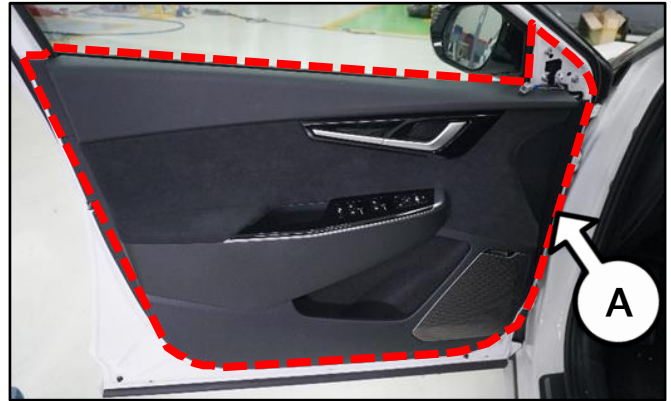
1. Remove the front door trim (A) by referring to the "Body (Interior and Exterior) → Front Door → Front Door Trim → Repair procedures" chapter in the applicable Shop Manual on KGIS.

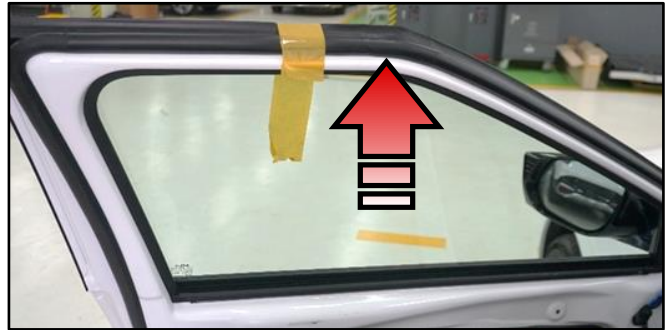
- 4a. Using both hands, hold glass from opposite sides and raise it up to detach from the door module.
- 4b. Clamp or tape it securely to the top of the door frame as shown.

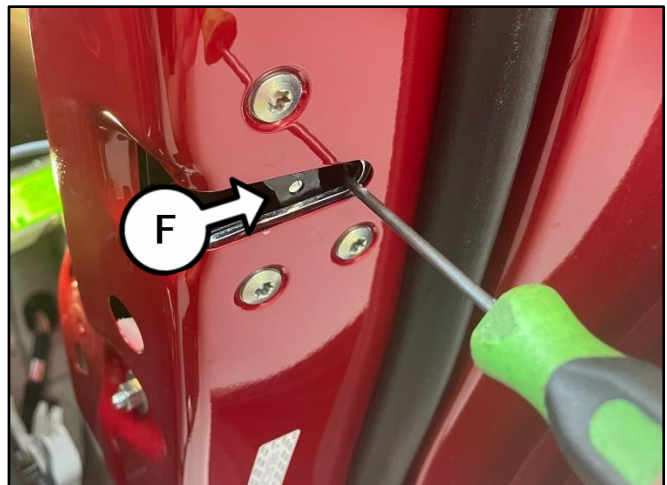
7. Manually close the door latch (F) with a screwdriver or similar tool.

Note: When working on the rear doors, the front doors must be closed, or both door latches in the locked position, to move the handles.

DO NOT shut the door with the latch in the closed position - doing so may damage the latch.

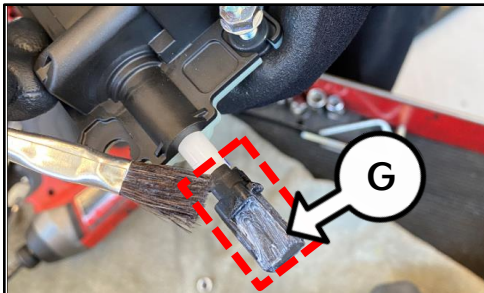
Be sure to apply grease to ALL FOUR (4) SIDES and END of the push rod plunger.
