GROUP	MODEL
CLI	2022MY EV6 (CV)
NUMBER	DATE
052	November 2022

## TECHNICAL SERVICE BULLETIN

SUBJECT: **SERVICE ACTION: DATC LOGIC IMPROVEMENT FOR  
CELSIUS TO FAHRENHEIT CONVERSION (SA513)**

This bulletin provides the procedure to update the software logic of the Dual Auto Temperature Controller (DATC) on some 2022MY EV6 (CV) vehicles produced from November 17, 2021 through September 16, 2022, in order to prevent the temperature units from changing to Celsius from Fahrenheit when using remote functions. Follow the procedure outlined in this publication to apply the improved logic to the 'AIRCON' system using the KDS ECU Upgrade function as described in this bulletin. For confirmation that the latest reflash has been applied to a vehicle you are working on, verify the ROM ID using the table on page 3 of this bulletin. Before conducting the procedure, verify that the vehicle is included in the list of affected VINs.

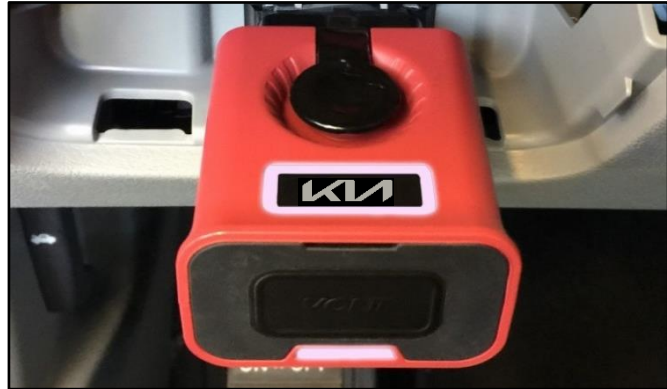
- 1. Connect the VCI-II to the OBD-II connector, located under the driver's side of the instrument panel.

**NOTICE**  
The ECU upgrade function on KDS operates wirelessly. It is not necessary to perform the upgrade via USB cable.

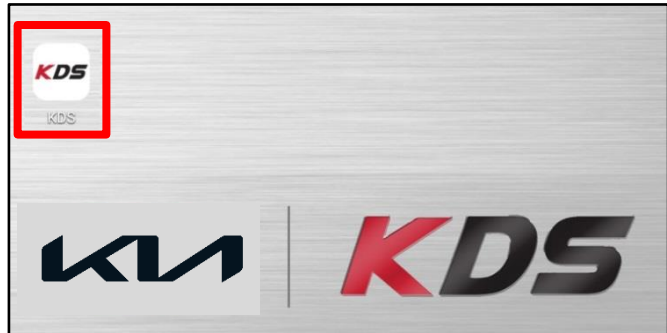
- 2. With the ignition ON, turn ON the KDS tablet. Select 'KDS' from the home screen.

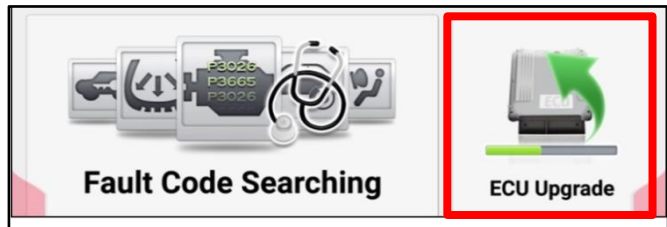
- 4. Select 'ECU Upgrade'.

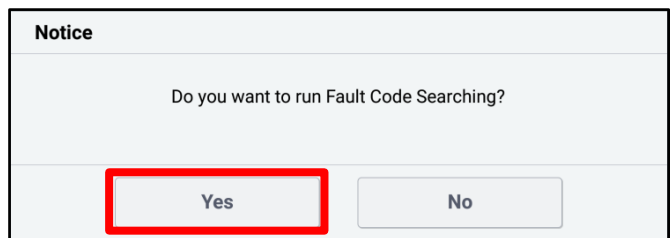
- When prompted, select 'YES' to check for Diagnostic Trouble Codes (DTC) and erase any DTCs stored such as EPS, ESC, and TPMS that may have been set during the upgrade.
