TECHNICAL SERVICE BULLETIN

SERVICE ACTION: CLUSTER LOGIC IMPROVEMENT FOR ADAS ALERT VOLUME CHANGE (SA517)

This bulletin provides the procedure to update the software logic of the Cluster (CLU) system on some 2023MY vehicles to allow the Advanced Driver Assistance System (ADAS) default alert volume to be changed. Kia is requesting the completion of this Service Action on all affected vehicles in dealer stock, prior to delivery. Follow the procedure outlined in this publication to apply the improved logic to the 'CLU' system using the KDS ECU Upgrade function as described in this bulletin. For confirmation that the latest reflash has been applied to a vehicle you are working on, verify the ROM ID using the table on pages 3-5 of this bulletin. Before conducting the procedure, verify that the vehicle is included in the list of affected VINs.

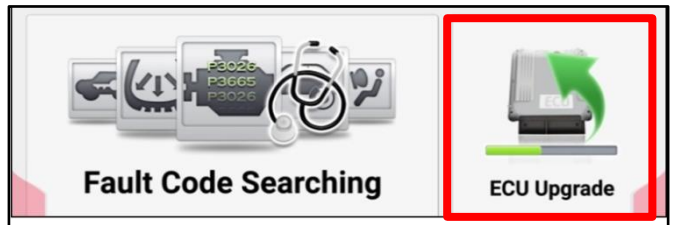
4. Select 'ECU Upgrade'.

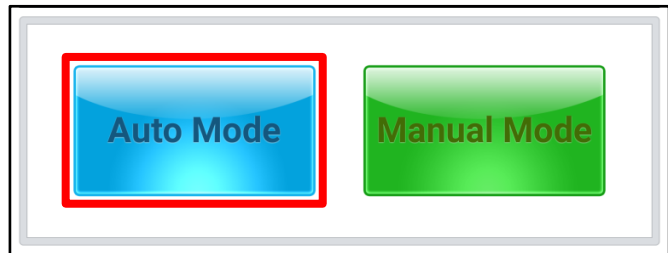
- Select the CLU system under the System selection menu. Touch ID Check (D) and confirm that the latest update is available. Select Upgrade Event #629, #630, #631, #632, #633, #634, or #635, and select Upgrade to continue.

- The ECU upgrade will begin and the progress of the upgrade will appear on the bar graph. Upgrade part (1/2) (E) will download the upgrade event to the VCI-II. Upgrade part (2/2) (F) will upgrade the ECU.

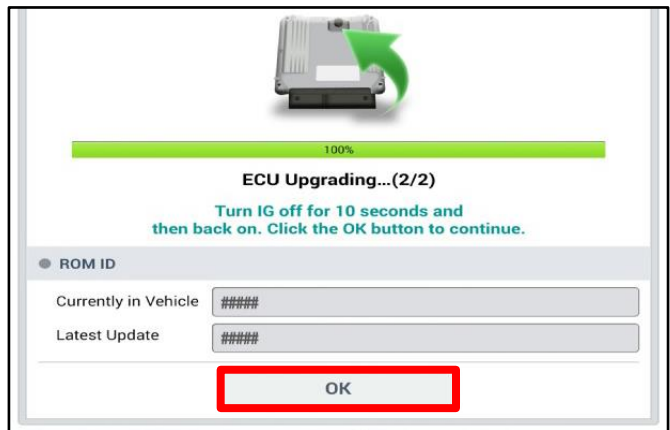
- When instructed on the KDS, turn the ignition OFF for ten (10) seconds then back on. Select 'OK' to continue.

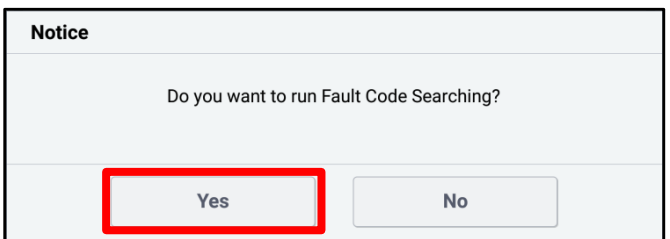
- When prompted, select 'YES' to check for Diagnostic Trouble Codes (DTC) and erase any DTCs stored such as EPS, ESC, and TPMS that may have been set during the upgrade.
