| ELE | 2022MY EV6 (CV) |

TECHNICAL SERVICE BULLETIN

SERVICE ACTION: VCU SOFTWARE UPGRADE FOR i-PEDAL OPERATION (SA533)

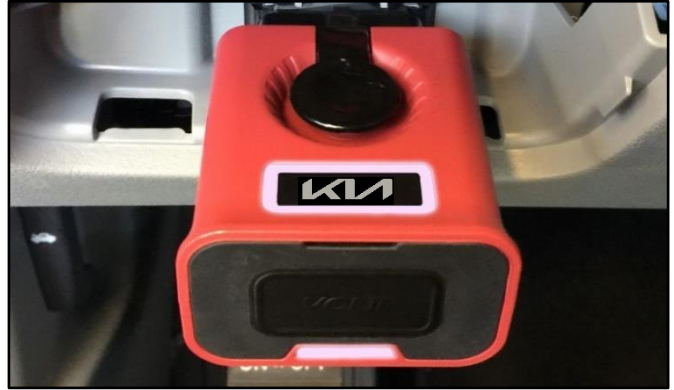
The ECU upgrade function on KDS operates wirelessly. It is not necessary to perform the upgrade via USB cable.

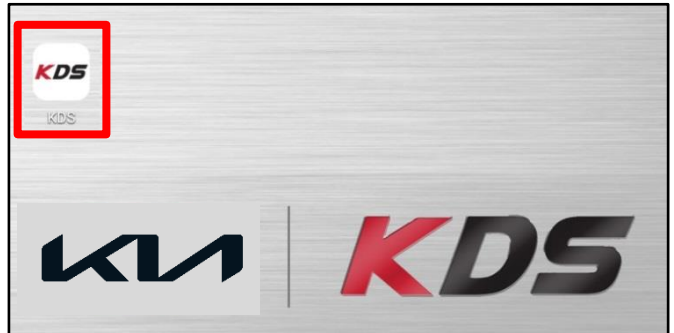
2. With the ignition ON, turn ON the KDS tablet. Select 'KDS' from the home screen.

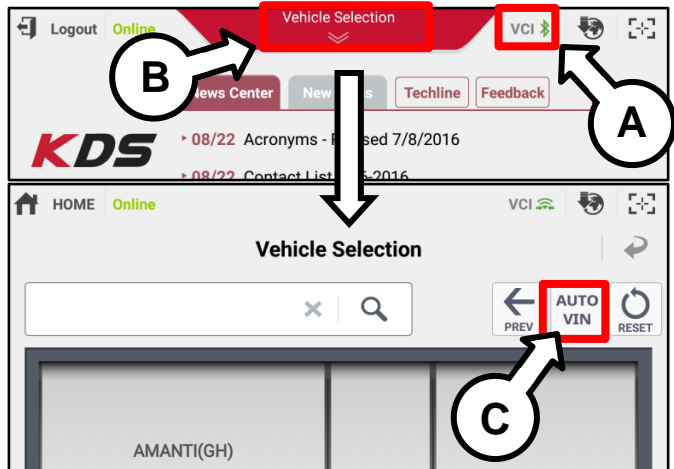
3. Confirm communication with VCI (A) and then configure the vehicle (B) using the 'AUTO VIN' (C) feature.

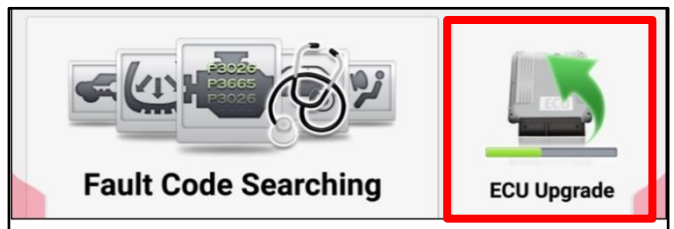
4. Select 'ECU Upgrade'.

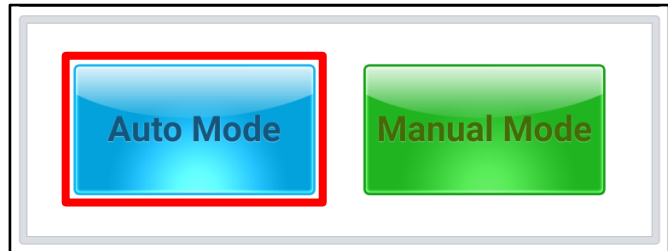
- Select Auto Mode.

Do NOT attempt to perform a Manual Mode upgrade UNLESS Auto Mode fails. Always follow the instructions given on the KDS in either Auto or Manual mode.

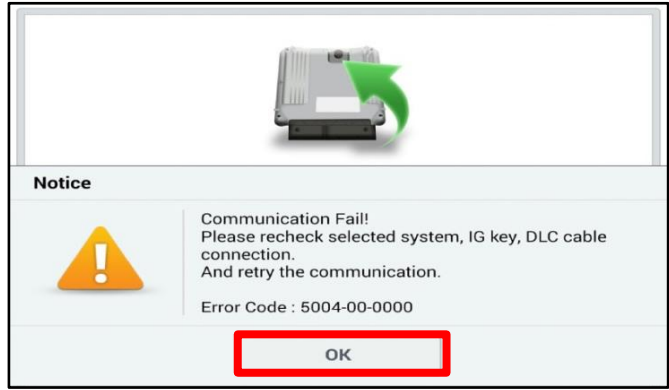
- If a "Communication Fail" screen appears, verify that the VCI-II and KDS are communicating properly. Select 'OK' and restart the from step 4.

If an error notice continues to appear or if the upgrade cannot be performed, DO NOT disconnect the KDS/VCI-II. Contact GIT America Help Desk at (888) 542-4371 or Techline.

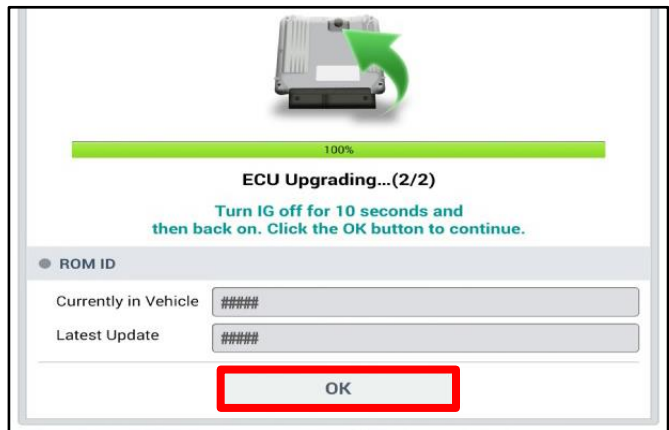
- When instructed on the KDS, turn the ignition OFF for ten (10) seconds then back on. Select 'OK' to continue.

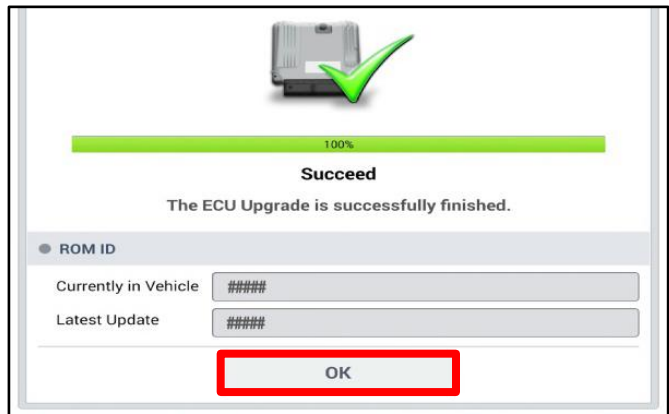
- Once the upgrade is complete, select 'OK' to finalize the procedure.

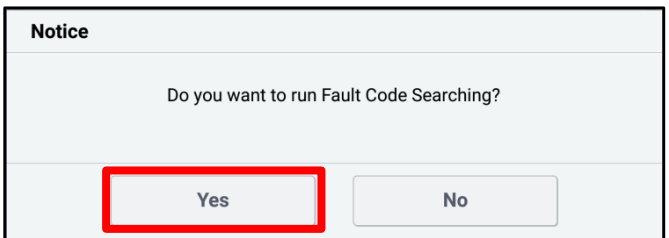
- When prompted, select 'YES' to check for Diagnostic Trouble Codes (DTC) and erase any DTCs stored such as EPS, ESC, and TPMS that may have been set during the upgrade.
