GROUP	MODEL
ELE	2023MY EV6 GT (CV GT)
NUMBER	DATE
305	August 2023

TECHNICAL SERVICE BULLETIN

VCU SOFTWARE LOGIC UPGRADE (SA541)

This bulletin provides information to upgrade the software logic of the Vehicle Control Unit (VCU) on certain 2023MY EV6 GT (CV GT) vehicles produced from August 25, 2022 through July 20, 2023, to optimize the brake lamp 'ON/OFF' logic to prevent momentary activation and deactivation of the brake lights when regenerative braking is in use while driving over uneven road surfaces (e.g. railroad crossings, raised pavement markers). This condition does not affect brake light activation when the brake pedal is depressed. Follow the procedure outlined in this publication to upgrade the software logic of the VCU system using the KDS ECU Upgrade function as described in this bulletin on the applicable vehicle. For confirmation that the latest reflash has been applied to a vehicle you are working on, verify the ROM ID using the table on page 3 of this bulletin. Before conducting the procedure, verify that the vehicle is included in the list of affected VINs.

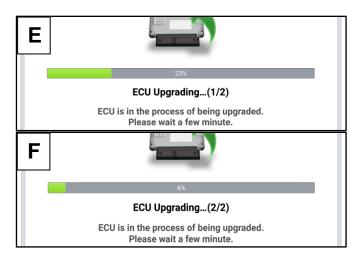
9. <u>If a "Communication Fail" screen appears</u>, verify that the VCI-II and KDS are communicating properly. Select **'OK'** and restart the from step 4.
