GROUP	MODEL
	ELE	2020-2023MY Multiple Models w/ AVN5W
	NUMBER	DATE
	303	August 2023
<h2>TECHNICAL SERVICE BULLETIN</h2>		
<b>SUBJECT: AVN 5.0 WIDE NON-RESPONSIVE RADIO ICON (AM, FM, SXM)</b>

This bulletin provides information to update the software on 5<sup>th</sup> Generation AVN wide on certain 2020-2023MY Kia vehicles (refer to model list on page 3) to remedy a ‘non-responsive’ or ‘inoperative’ radio (FM, AM, SXM, etc.) concern. The affected AVN unit on the vehicles may not respond when pressing the ‘RADIO’ hard key/button on the AVN unit or when selecting the ‘RADIO’ icon on the AVN menu screen. Follow the procedure outlined in this publication to update the software on 5<sup>th</sup> Generation AVN wide units using the applicable USB Flash Drive A or B for the applicable vehicle.

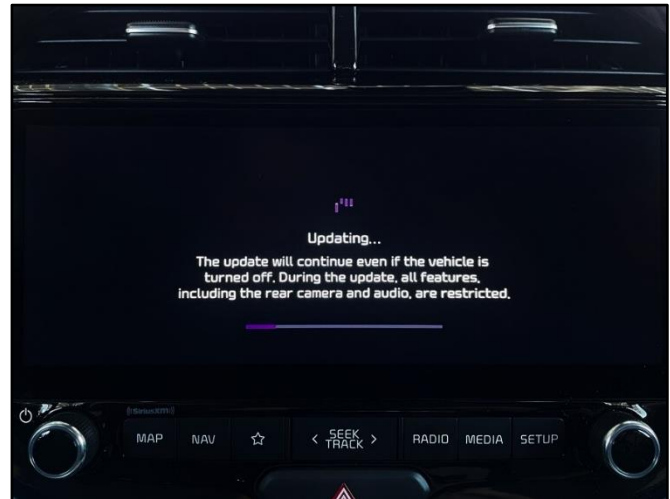
**Note:** There will be multiple occurrences where the Kia logo will appear or the display will be black during the update process. This is normal.

**DO NOT** turn the ignition switch 'OFF', start the engine, and/or remove the USB drive from the vehicle during the update process.
